Pedestrian Bridges – Wesley Lake

Retaining Walls – Wesley Lake

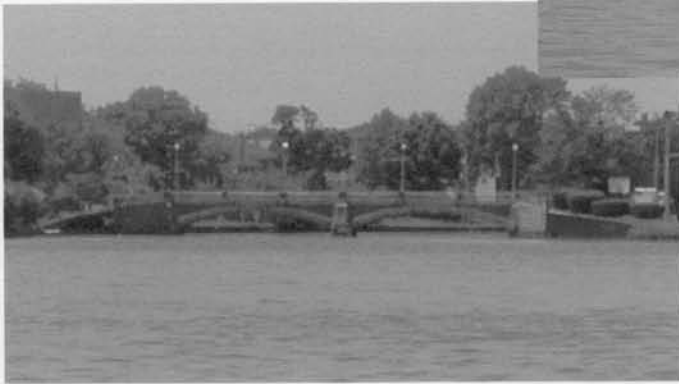
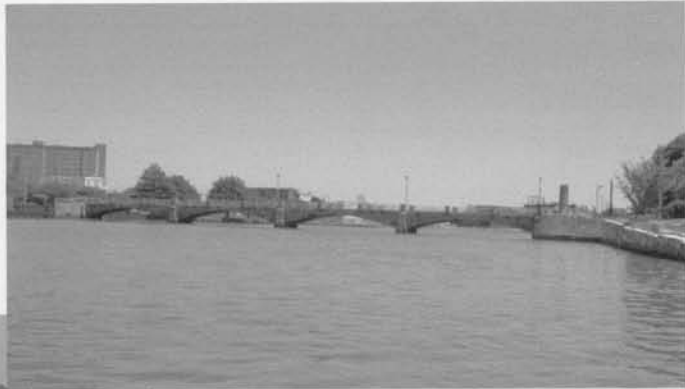
Sunday March 7, 2004, at the request of Mr Alan Oberman, the first steps of a survey to determine the structural integrity of the two pedestrian bridges spanning Wesley Lake were taken. These steps

include a visual examination of both structures, the beginning of a photographic record of conditions, and a mechanical assay of the concrete. Included in the scope of the project is a similar examination of the bulkheads and retaining walls lining the shores.

In this initial foray, being afoot, and not having access to the under-structure, we were limited to the bridge approaches, bed, balustrade, and those sections of the piers visible from the shore or roadbed.

A visual inspection can only provide indicators as to the problem, and suggest possibilities as to how one might attempt to rectify the situation. However, in order to accurately assess conditions, as they currently exist, it will be necessary to probe the structures. Possibilities include intrusive procedures such as coring, or non-intrusive techniques such as ultra-sound, or boroscopy. It is commonly accepted that the services of an engineer be retained to conduct or guide this process. Rick Burke, of Becht Engineering has been contacted; he has visited the site, and is preparing a proposal recommending technique and procedure for in depth analysis.

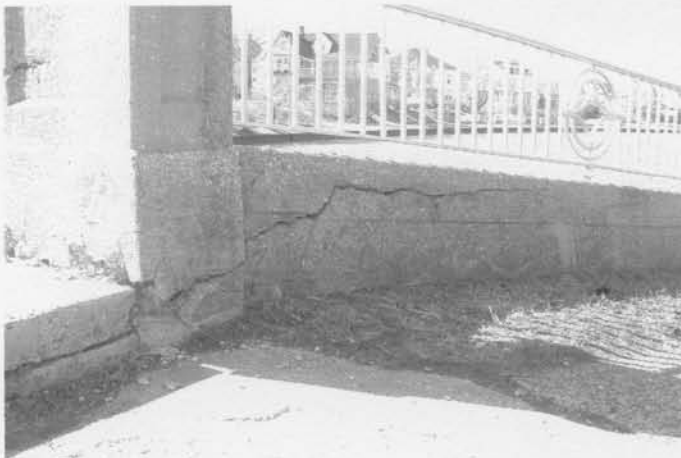
The breakdown is most notable due to the plenitude of cracks and flaws such as that shown, in the photo, at left. As will be seen in other images presented, these imperfections are numerous, and in their numbers somewhat daunting. However, when probing the concrete with a metal blade, the material itself proved to be hard and the aggregates well bonded.

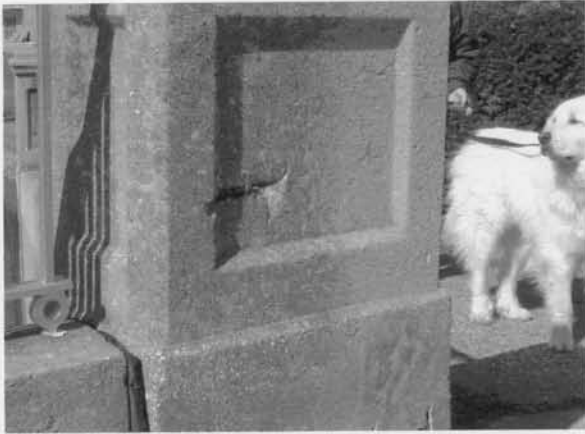
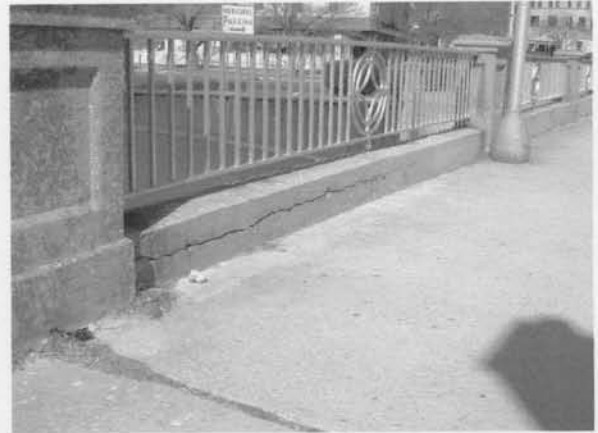
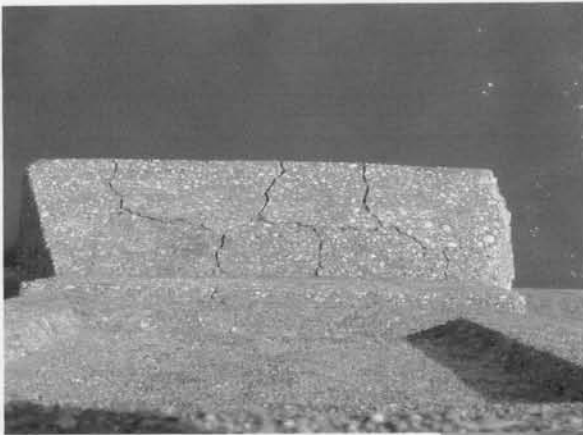
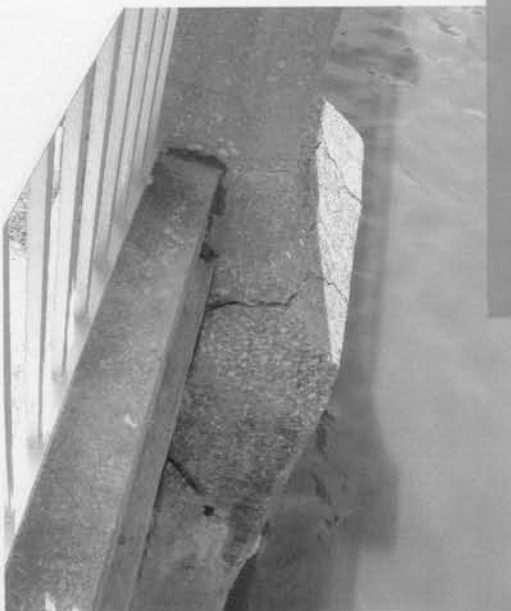
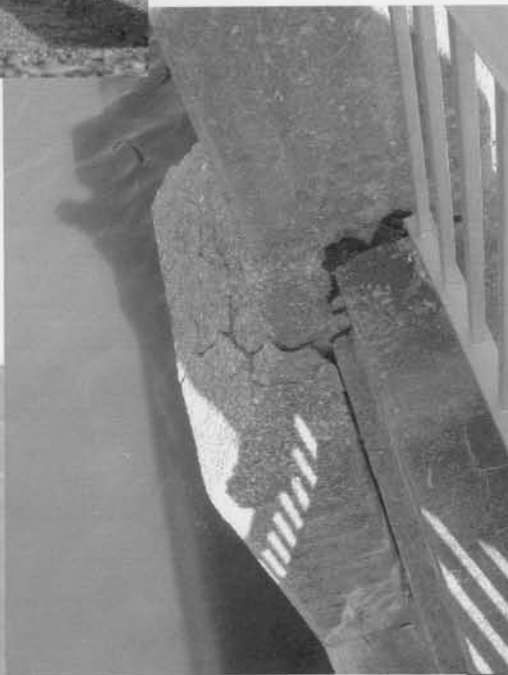
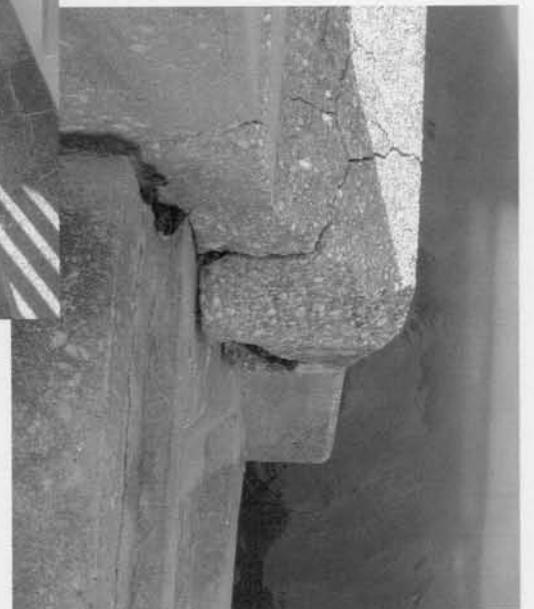
The two photos above, taken at the same approach as the first, are further examples of a similar decay. The four in the lower half of the page are indicative of the conditions prevalent among the piers that support the roadbed.

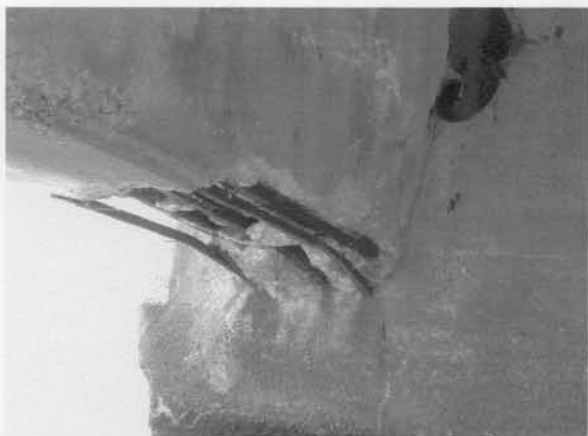
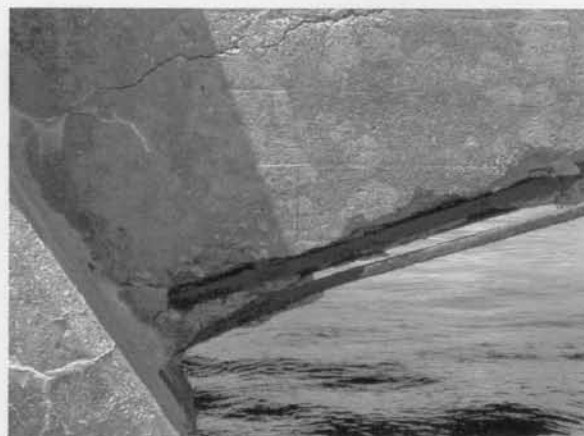
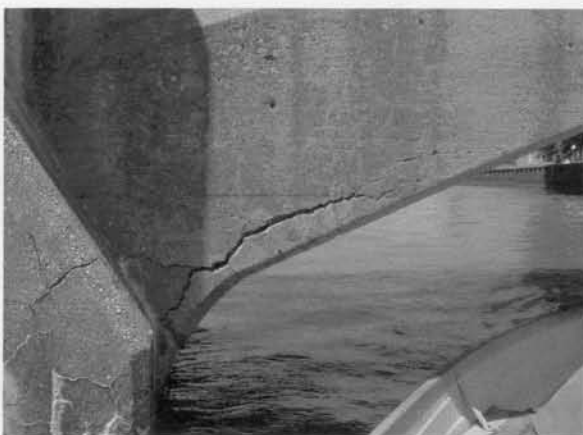
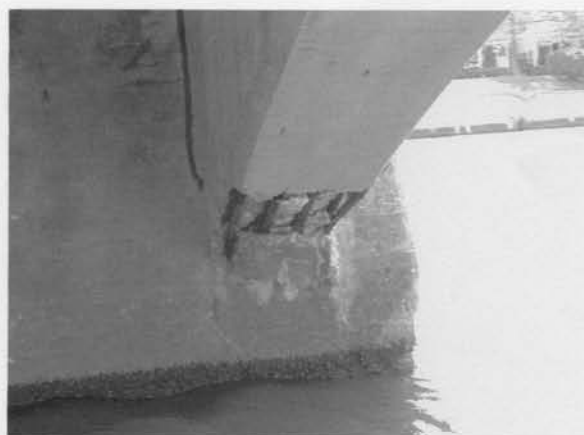
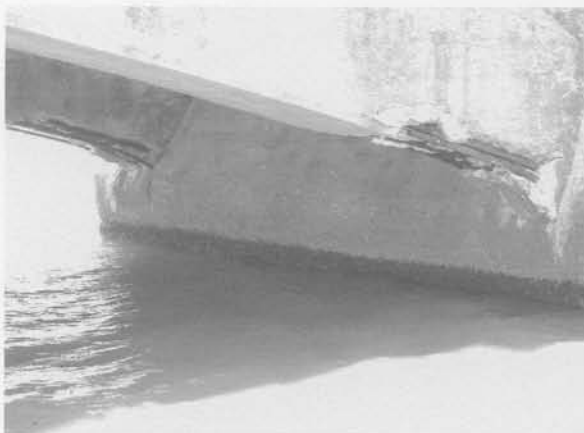
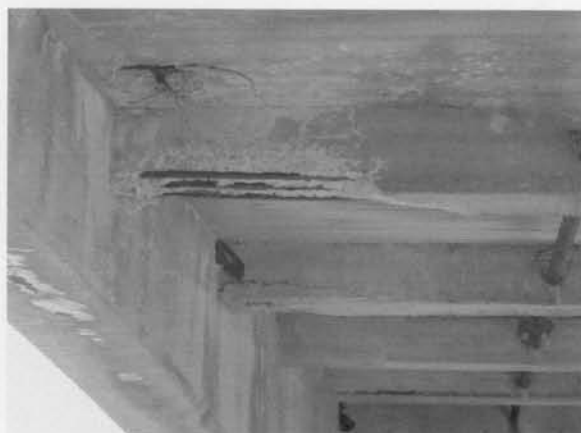
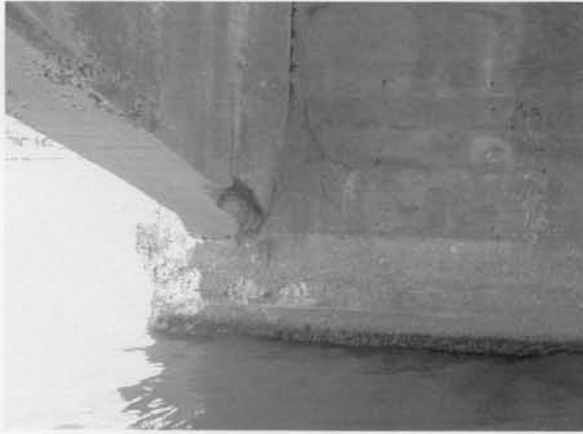
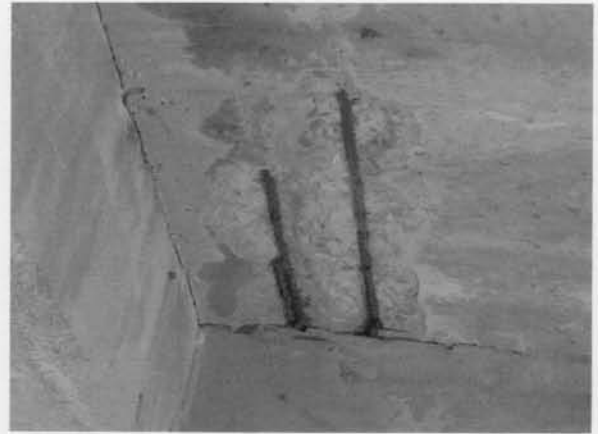
In order to gain a more complete understanding of the situation, an appointment was made to obtain the use of a boat, and examine the undersides of the bridges. On May 30, 2004, the following photos were taken.

- a) As with most problems in concrete structures, a major contributor is probably water infiltration.
- b) The concrete itself, although exhibiting many fractures and flaws is still for the most part hard and intact.

Water infiltration in reinforced concrete construction attacks in two ways. One causes the breakdown of the concrete itself through accretion of salts and acids, and the other, which seems more applicable to this particular situation, causes corrosion of the reinforcing rods. The oxides created by this corrosion occupy a larger volume than the intact metal and the expansion of the mass supplies sufficient internal pressure to crack the concrete. Once these cracks occur, increased ingress for moisture accelerates the corrosion, resulting in further deterioration. The reinforcing rods in these last eight images appear to have been set too close to the surface of the pour, and so, expansion of the oxides has caused first cracking, as shown in the earlier photos, and then exfoliation, exposing the rods completely.

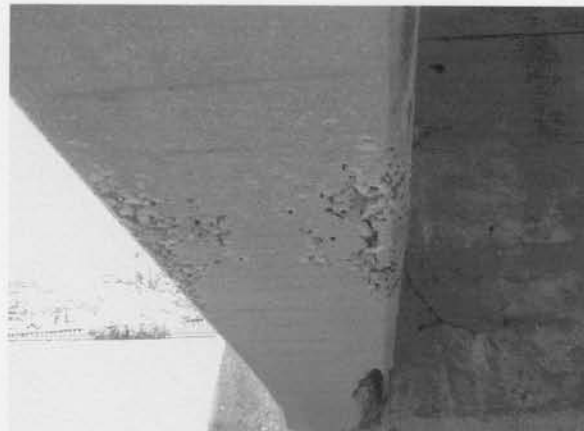
Porosity due to poor compaction during the initial pour, such as that shown, at right, probably also contributed to the decay.

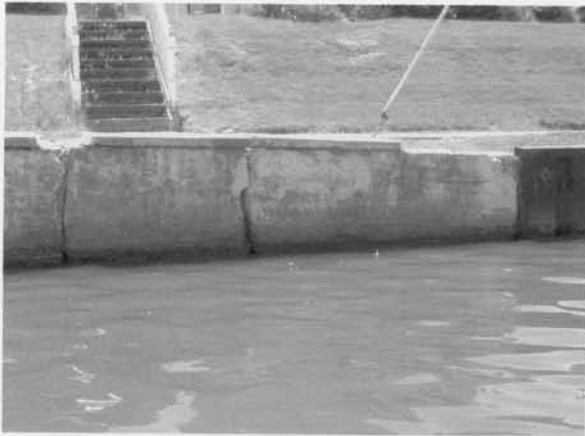
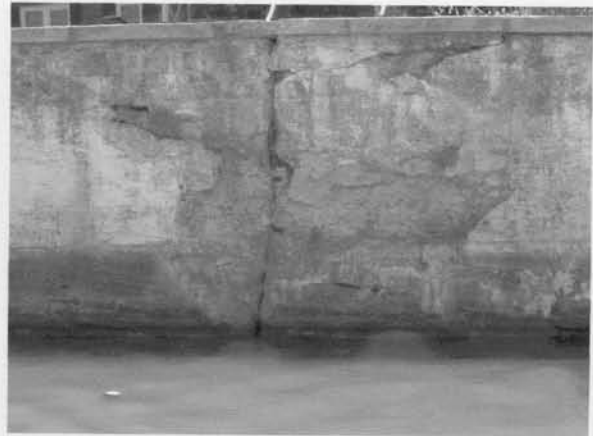
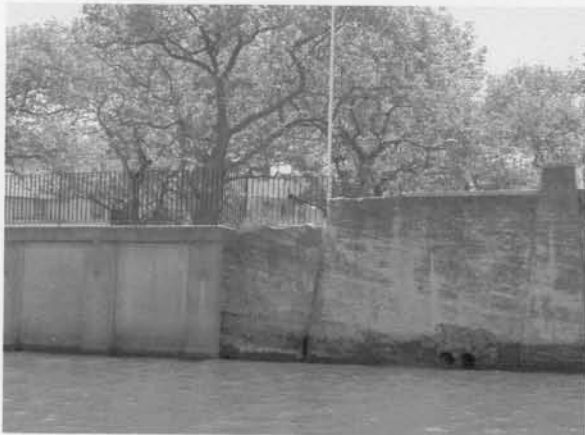
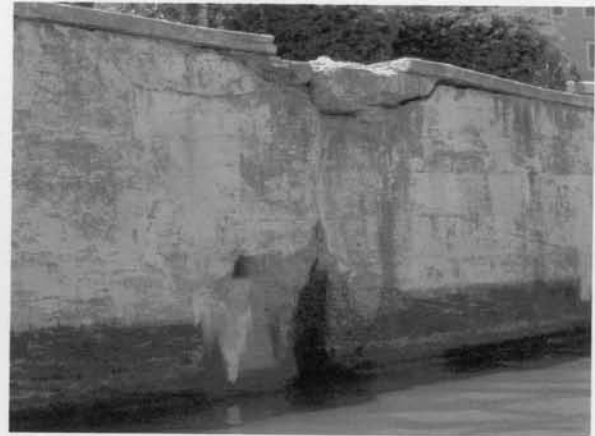
As the photos above illustrate, there has been significant decay in the concrete retaining walls that line the lake. Cracks, shifted sections, and crumbling are the major concerns. For the most part, as with the bridges, the concrete is still hard and well bonded. At this time it should not be too difficult to stabilize the segments relative to each other, and inject a grout to seal the cracks. Likewise, excision and repair, of the crumbled areas, should not present too great a difficulty.

There is noticeable rot in the metal bulkheads that line the balance of the shore. Areas have corroded to the point that soil backing up to the walls is washing into the lake, leaving potentially dangerous depressions. In addressing these problems, it is suggested that the product line and services of a company called Green Mountain International, Inc, be explored. They
